# PRODUCT SUPPORT TECHNICAL BULLETIN

July 5, 2023

## Issue: WL900/WS12000/I12 Noisy Booster Pump

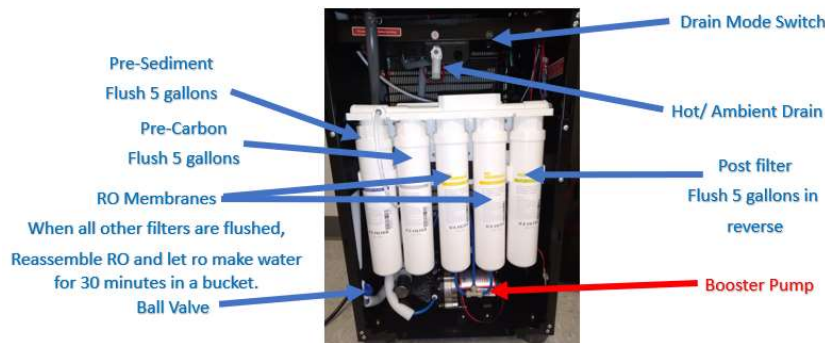
Booster pump feeding the RO membranes making a tapping sound when unit is producing water.

**2:** Remove the lower front panel and locate the booster pump. It is clearly visible in the middle of the floor pan, below the RO filter assembly.

Replace booster pump.

**3:** Remove all four screws holding the pump in place and place a micro-fiber towel under the pump.

**4:** Disconnect tubing, use towel to collect any water coming from the tubing, and disconnect the electrical connections.

**5:** Install replacement booster pump by securing it in place with four screws and reconnect the water and electrical connections.
