PRODUCT SUPPORT TECHNICAL BULLETIN

July 5, 2023

Issue: i12 Drip Tray not Draining/Draining Slowly

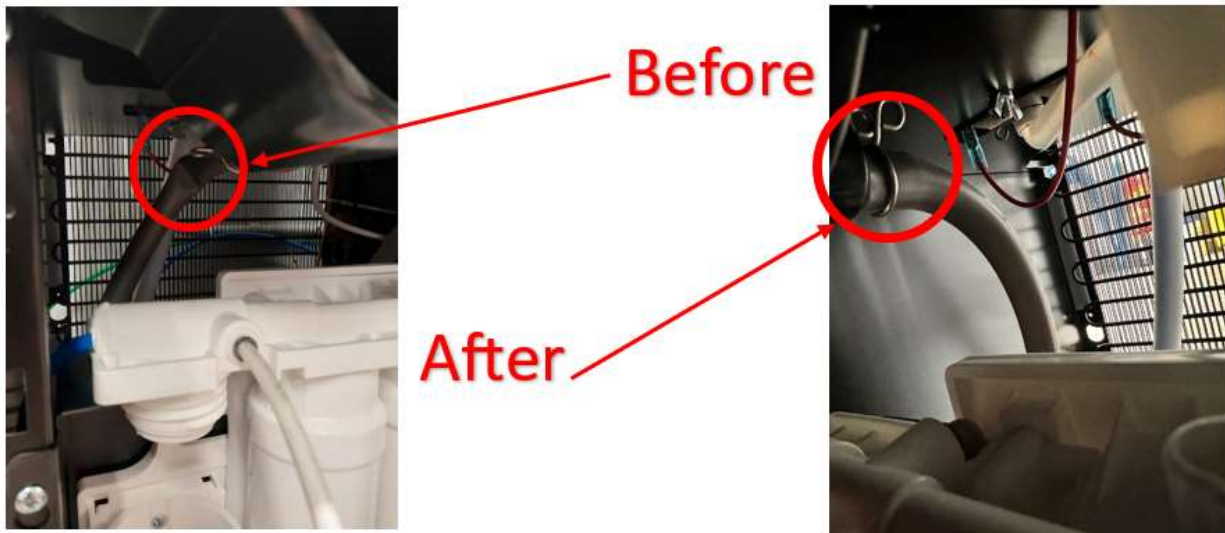
Tubing connected to the drain port of the drip tray can be kinked, causing water collected in drip tray to not drain or drain slowly.

Resized drain tube length.

1. Remove the lower front panel to gain access to the drain tube that connects to the drain port of the middle panel where the drip tray slides in. It is located on the lower left-hand corner of the middle panel.
2. Remove the tube by sliding the clamp away from the nipple. Once removed, cut 1-1/4" off the end of the drain tube.
3. Reconnect the tube and secure the clamp back onto the nipple.
