PRODUCT SUPPORT TECHNICAL BULLETIN

October 20, 2023

Issue: i12 Circulation Pump seal may cause drips

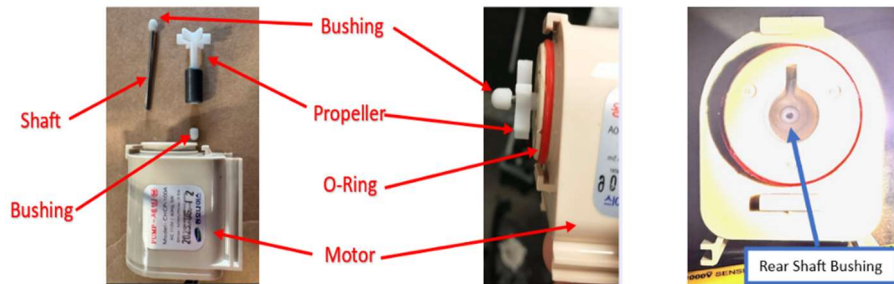
The circulation pump propeller shaft is not properly seated in the rear bushing causing the circulation pump to not seated correctly into the pump manifold.

4. Remove propeller shaft assembly and reseal it back into the circulation pump body ensuring that the propeller shaft seats correctly into the Rear Shaft Bushing.
