# PRODUCT SUPPORT TECHNICAL BULLETIN

## Issue: i16 No Dispense from Ambient at Time of Installation

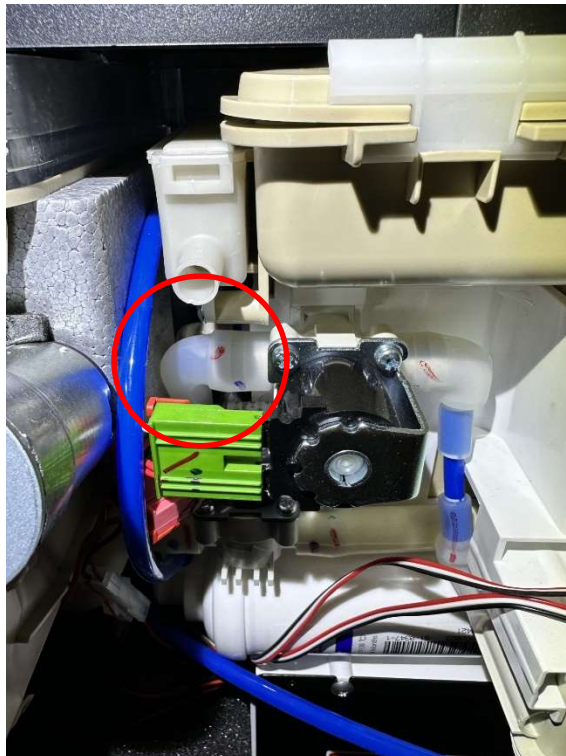
An airpocket can form in the elbow of the silicon tubing on the "IN" side of the ambient dispense solenoid.

1. Remove the lower front panel to gain access to the silicone tube that connects to the IN port of the ambient solenoid. It is located on the lower left-hand side of the solenoid (pictured below).
2. To clear the air pocket, squeeze the clear tube (circled in red) on the inlet side of the ambient solenoid, while pressing the water dispense button.
3. Test ambient water dispense prior to reassembling the unit.

Remove air pocket.
